Transportation Safety Board of Canada

Marine Investigation Report M93W0008

Multiple Capsizings

Group of Chartered Sea Kayaks
Laskeek Bay, Queen Charlotte Islands,
British Columbia
30 July 1993

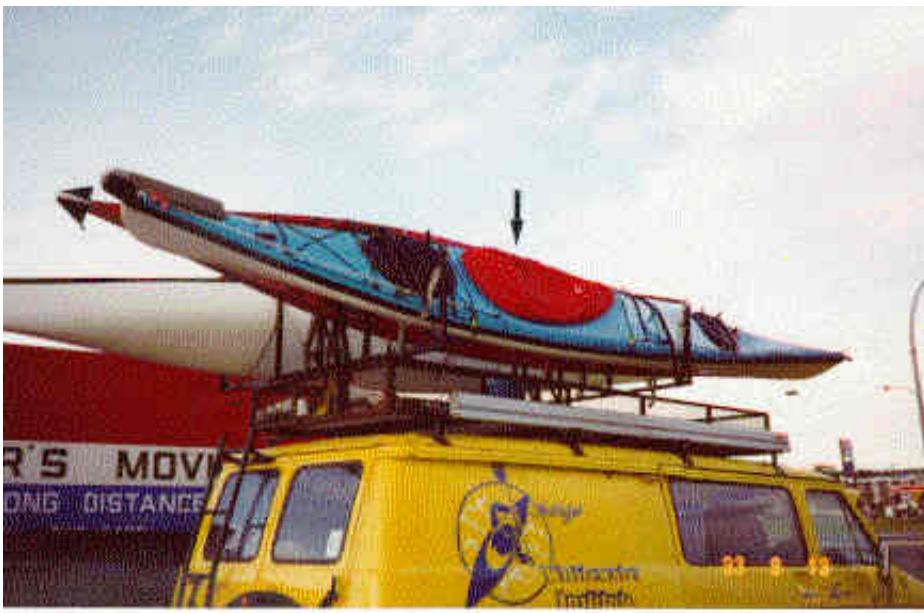
Type A Kayak

Type A is a single-seat sea kayak, 4.88 m in length and 0.61 m in breadth. It is moulded in fibreglass with two transverse watertight bulkheads dividing the kayak into three compartments. The bow and stern compartments contain foam buoyancy material in their forward and after extremities. The rest of each compartment is used for the storage of equipment. Access to the compartments is through waterproof hatches in the deck. The cockpit at the centre of the kayak is protected against water ingress by means of a skirt which fits around the kayaker's waist and the cockpit coaming. To reduce the volume of the cockpit and to minimize downflooding in the event of a capsizing, it is possible to use an insert known as a sea-sock. The sea-sock fits into the cockpit and is firmly secured around the cockpit coaming.

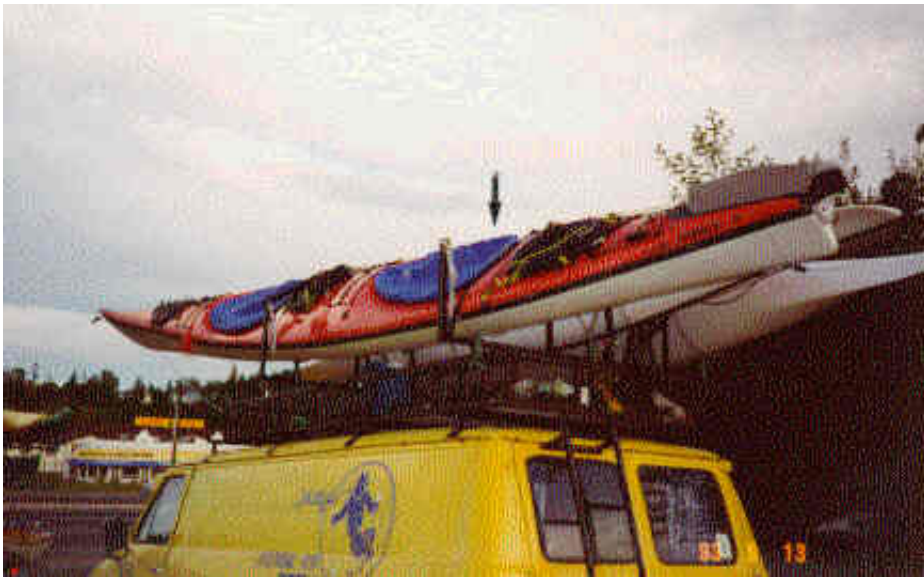
Type B Kayak

Type B is a double-seat sea kayak, 6.6 m in length and 0.76 m in breadth. It is built of moulded fibreglass with four transverse watertight bulkheads. There are two cockpits, a centre compartment, and bow and stern

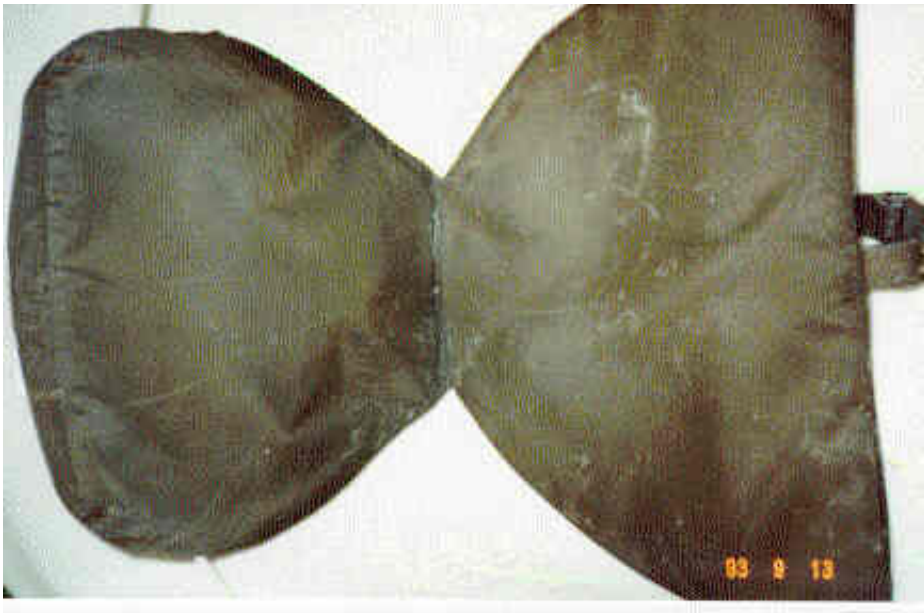
As a result of the back support cushion in another kayak not being secured, the woman using the kayak was unable to reach the foot pedals used to steer the rudder. This lack of control of the kayak caused its occupant to panic, quit the group and contributed to the confusion during the SAR operation. In the circumstances, it was fortuitous that this person was able to make a landing although she was injured in the process.

Cushion similar to the one lost when type C Kayak capsized.

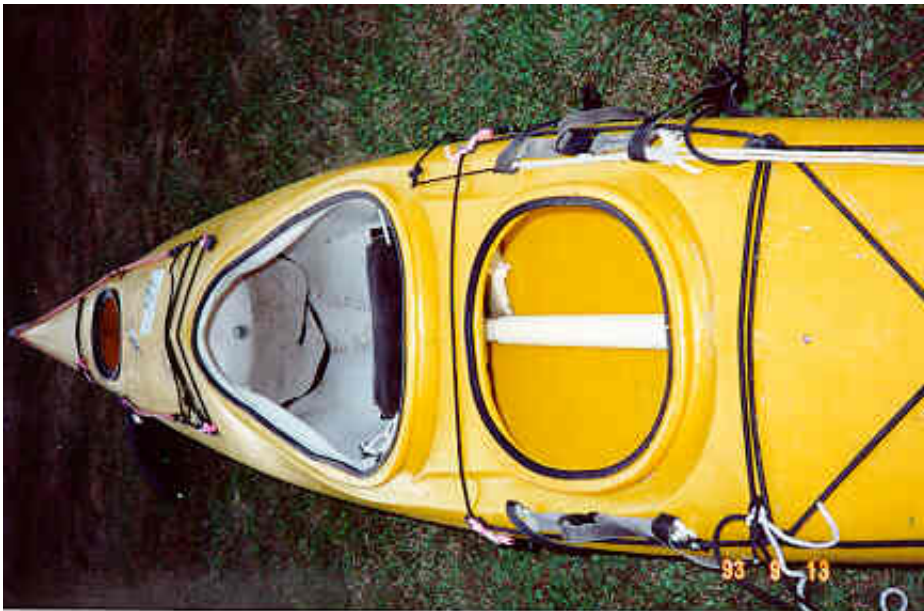
Type C Kayak

Type C is a single-seat sea kayak, 5.0 m in length and 0.603 m in breadth. It is made of cross-linked polyethylene. The one-piece hull is constructed in a heated mould. In this particular design, bulkheads are replaced by a permanently installed rigid sea-sock or pod. Such an installation reduces the size of the cockpit. There is a pumping arrangement for the pod but not for the hull compartment.

The polyethylene single-seat kayak which sank was later recovered. As the forward and after watertight hatch covers were still intact, it appeared that downflooding had occurred through the pod seal. There was no damage to the other kayaks.

The capsizing and downflooding of the second kayak are probably attributable to the fact that the U-shaped outer pod seal had been pulled off the coaming probably as the occupant exited the pod when the kayak capsized. It could not be determined if the inner seal was defective because the owner later replaced both seals. These replacements cured the leak but it is unknown which replacement cured the problem.
