Transportation Safety Board of Canada

Marine Investigation Report M93W0008

Multiple Capsizings

Group of Chartered Sea Kayaks
Laskeek Bay, Queen Charlotte Islands,
British Columbia
30 July 1993

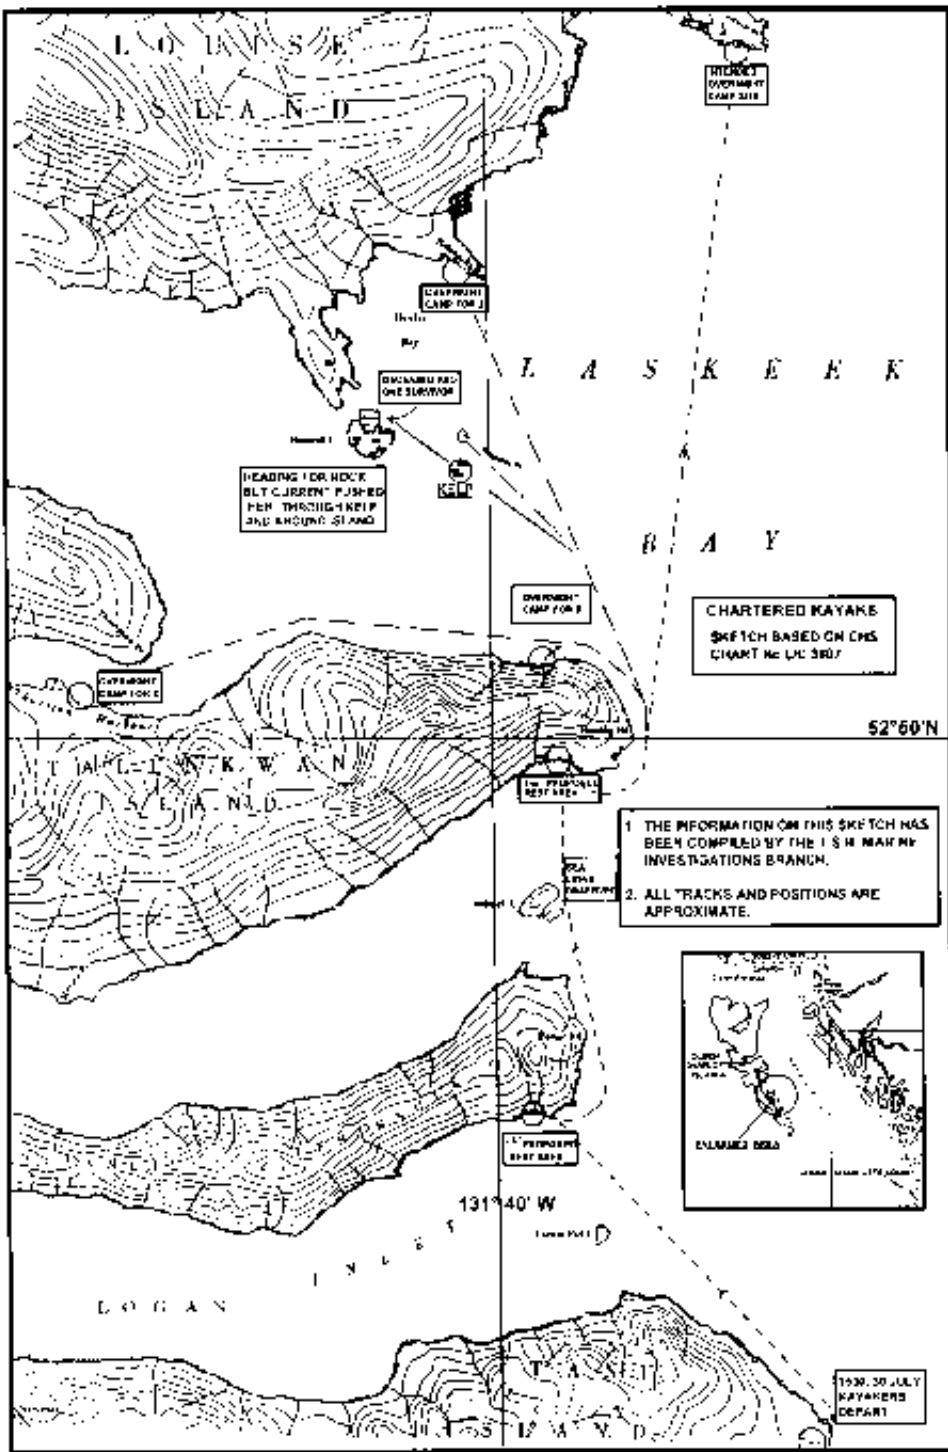
Appendix B - Sketch of the Occurrence Area

As the first group approached Heming Head and came out of the lee of Kunga Island, B.C., the wind and wave heights increased. The head guide found that the second rest area was also unusable because of the heavy waves breaking on the beach. He then decided to try to land on the north-west side of Heming Head.

By the time the first group reached Heming Head, several of the charterers were feeling anxious about their ability to handle a kayak in the prevailing conditions. The wind was increasing to about 20 knots and the waves were up to 3 m in height, with breaking crests. Both wind and waves were from the south-east. The waves were higher in the shoal area close by Heming Head.
